Martin Luther King, Jr. Building Renovation

RE: Martin Luther King Jr. Building Renovation - Initial Findings Submittal

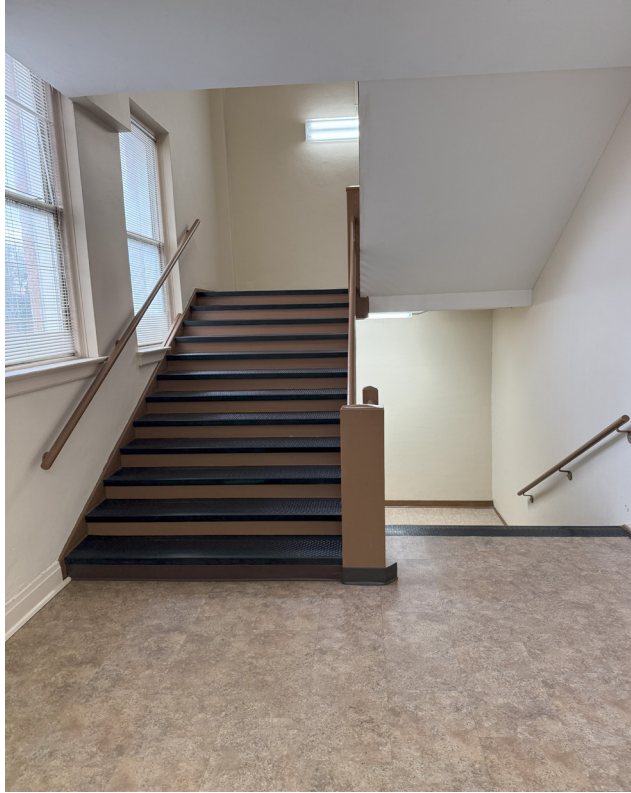
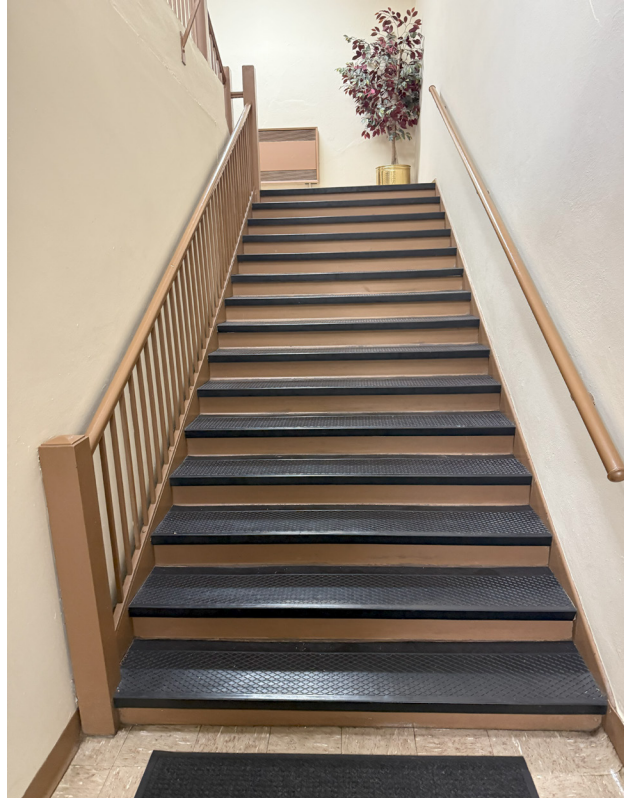
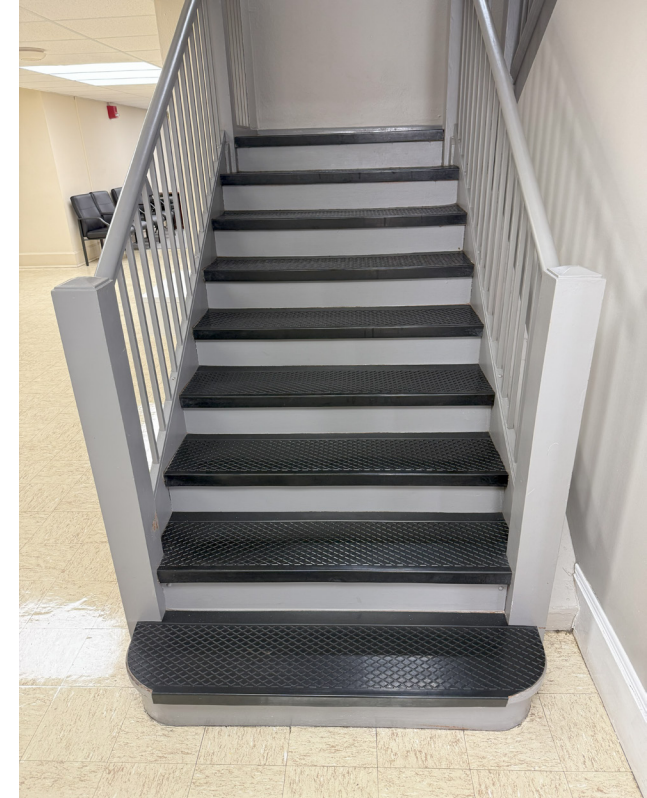
MEANS OF EGRESS

The building's stairways do not meet current (or recent) building code standards. While there are three stairways, only the main stair connects all four floors. However, it lacks a fire-rated enclosure, rendering it non-compliant. The other two stairways only connect the second and third floors, and while the need for a rated enclosure for at least one of these two stairs might be debatable, neither has a proper exit directly to the exterior. Two means of egress are required for each floor to meet current building code standards. The ground floor has two exits, but the second, third, and fourth floors each effectively only have one.

Main Stair: Provide an enclosure for the main stair at the front of the building by adding fire ratings to the existing walls and new walls and doors at the landings of the second, third, and fourth floors.

New Stair Tower: Design and construct a new stair tower that connects all stories and provides a direct exit to the exterior.

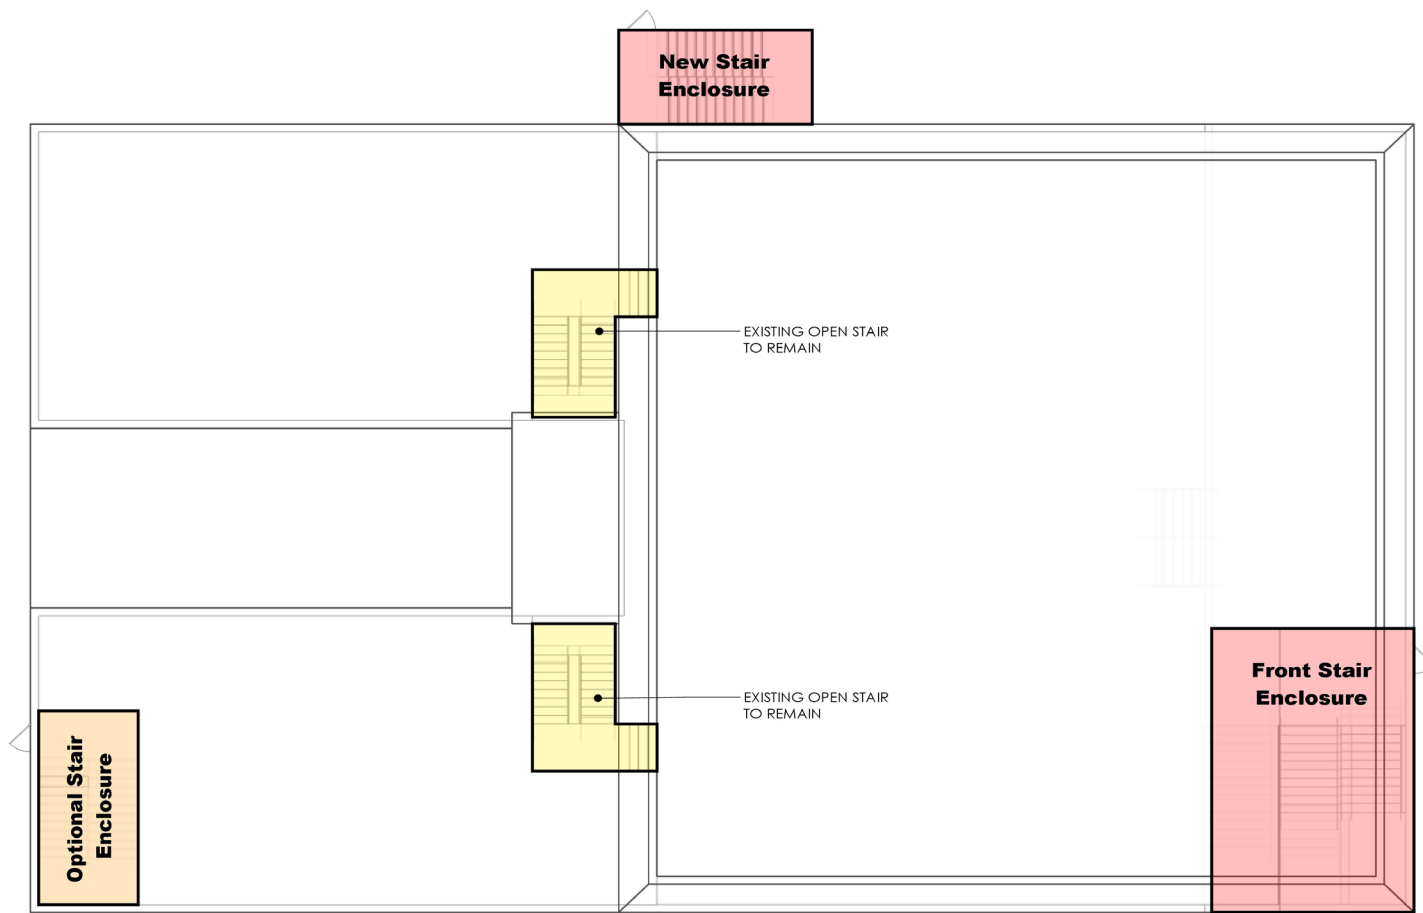
MEANS OF EGRESS OPTIONS

In order to address the lack of a means of egress system, we recommend enclosing the main stairway at the front of the building with a fire rated enclosure and a new “exit only” door to the public way. Additionally, a second enclosed stairway is required to provide a second means of egress from all stories. We propose adding a stair tower to the exterior of the east facade (parking lot side). The new tower would serve as the second means of egress from the 2nd, 3rd, and 4th stories. The open stairs connecting the 2nd and 3rd stories may be able to remain as they are. Optionally, a second stair tower may be constructed in the Northwest corner of the building (rear). This stair would only serve the 2nd and 3rd floors and would aid in addressing or eliminating any dead-end corridors that may need to be addressed.

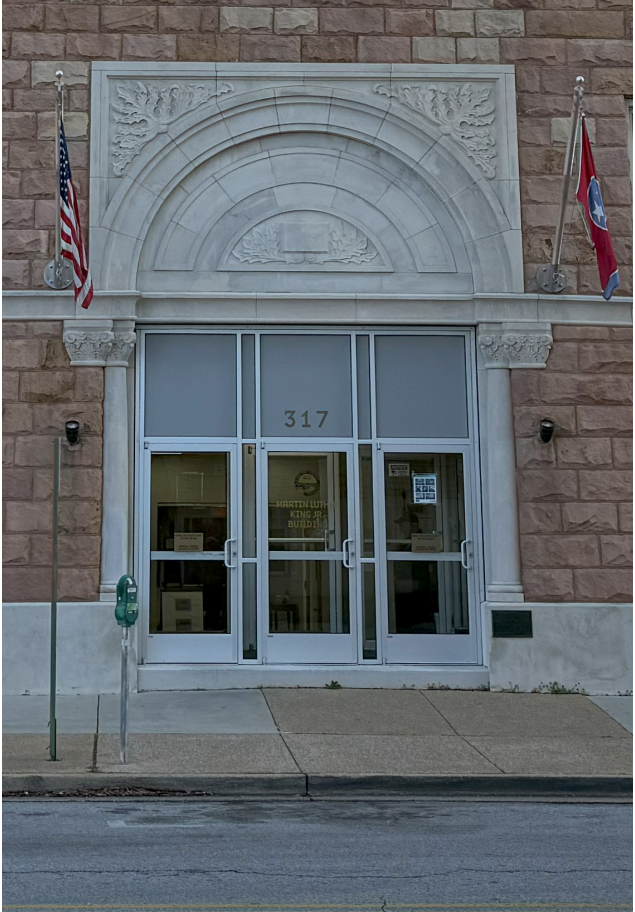
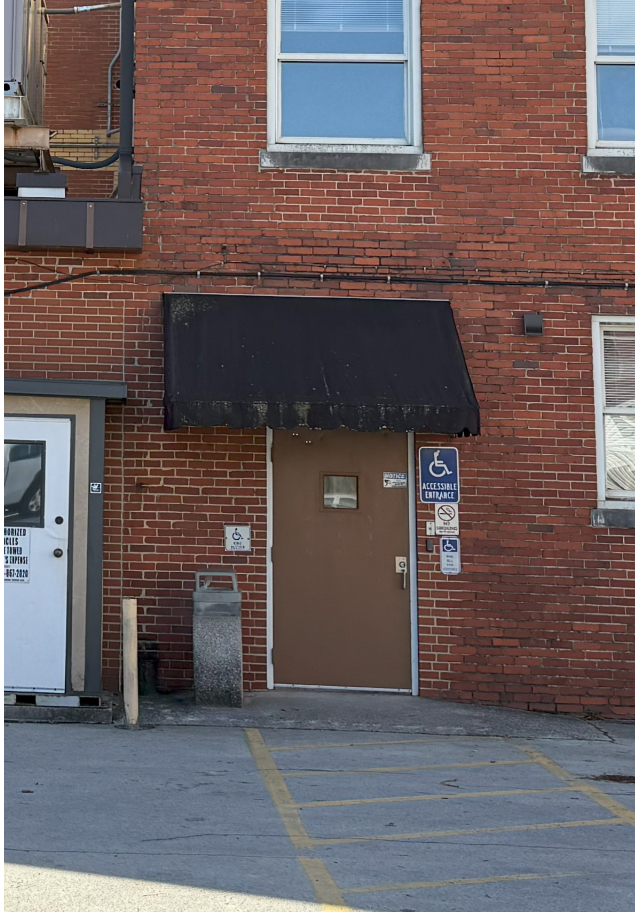
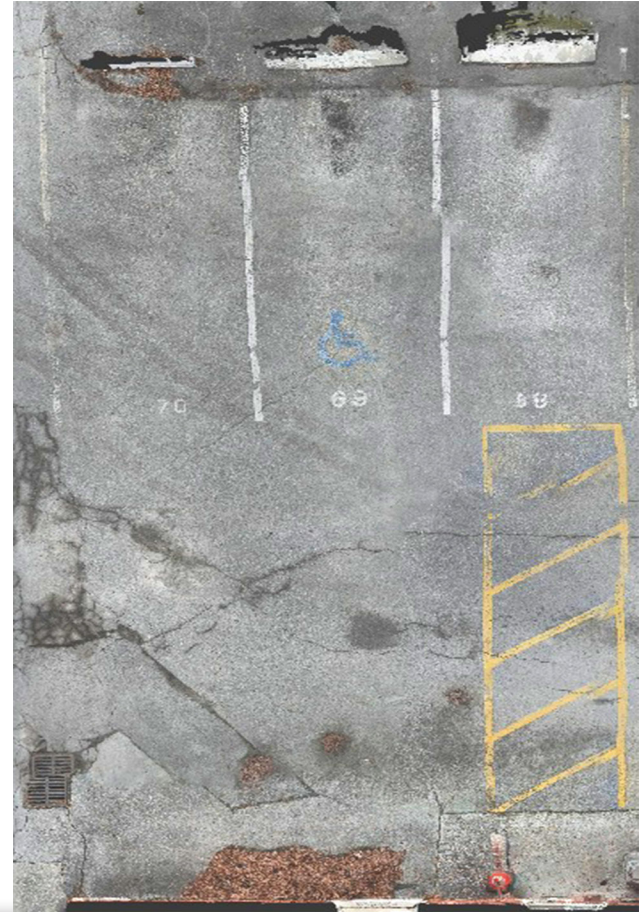
ACCESSIBILITY

The building's main entrance has a 7" step and a 5-step stairway from the lobby to the main level, making accessible access difficult. While a rear parking lot entrance is labeled accessible, it lacks a proper landing at the top of its 1:12 ramp, and the adjacent accessible parking space lacks a required 5' clear aisle (though a striped area connects the space to the entrance). Slopes in the parking lot and along the striped path seem compliant. An elevator serves all four floors, but the split-level 3rd floor leaves about half of that level inaccessible. Any essential functions on the inaccessible part of the 3rd floor must be duplicated on an accessible level. The current bathrooms do not meet 2010 ADA standards, but there appears to be room to modify them for compliance.

Rear Entrance: Install a level landing at the top of the ramp at the accessible entrance. Restripe the adjacent parking space to include a 5' clear aisle complying with accessibility standards.

3rd Floor: Relocate or duplicate any essential functions (conference rooms, offices, break rooms, restrooms, etc.) from the inaccessible portion of the 3rd floor to an accessible level. Consider a platform lift or other means to provide access to the split level if feasible.

Bathrooms: Develop a plan to renovate the bathrooms to meet 2010 ADA standards.

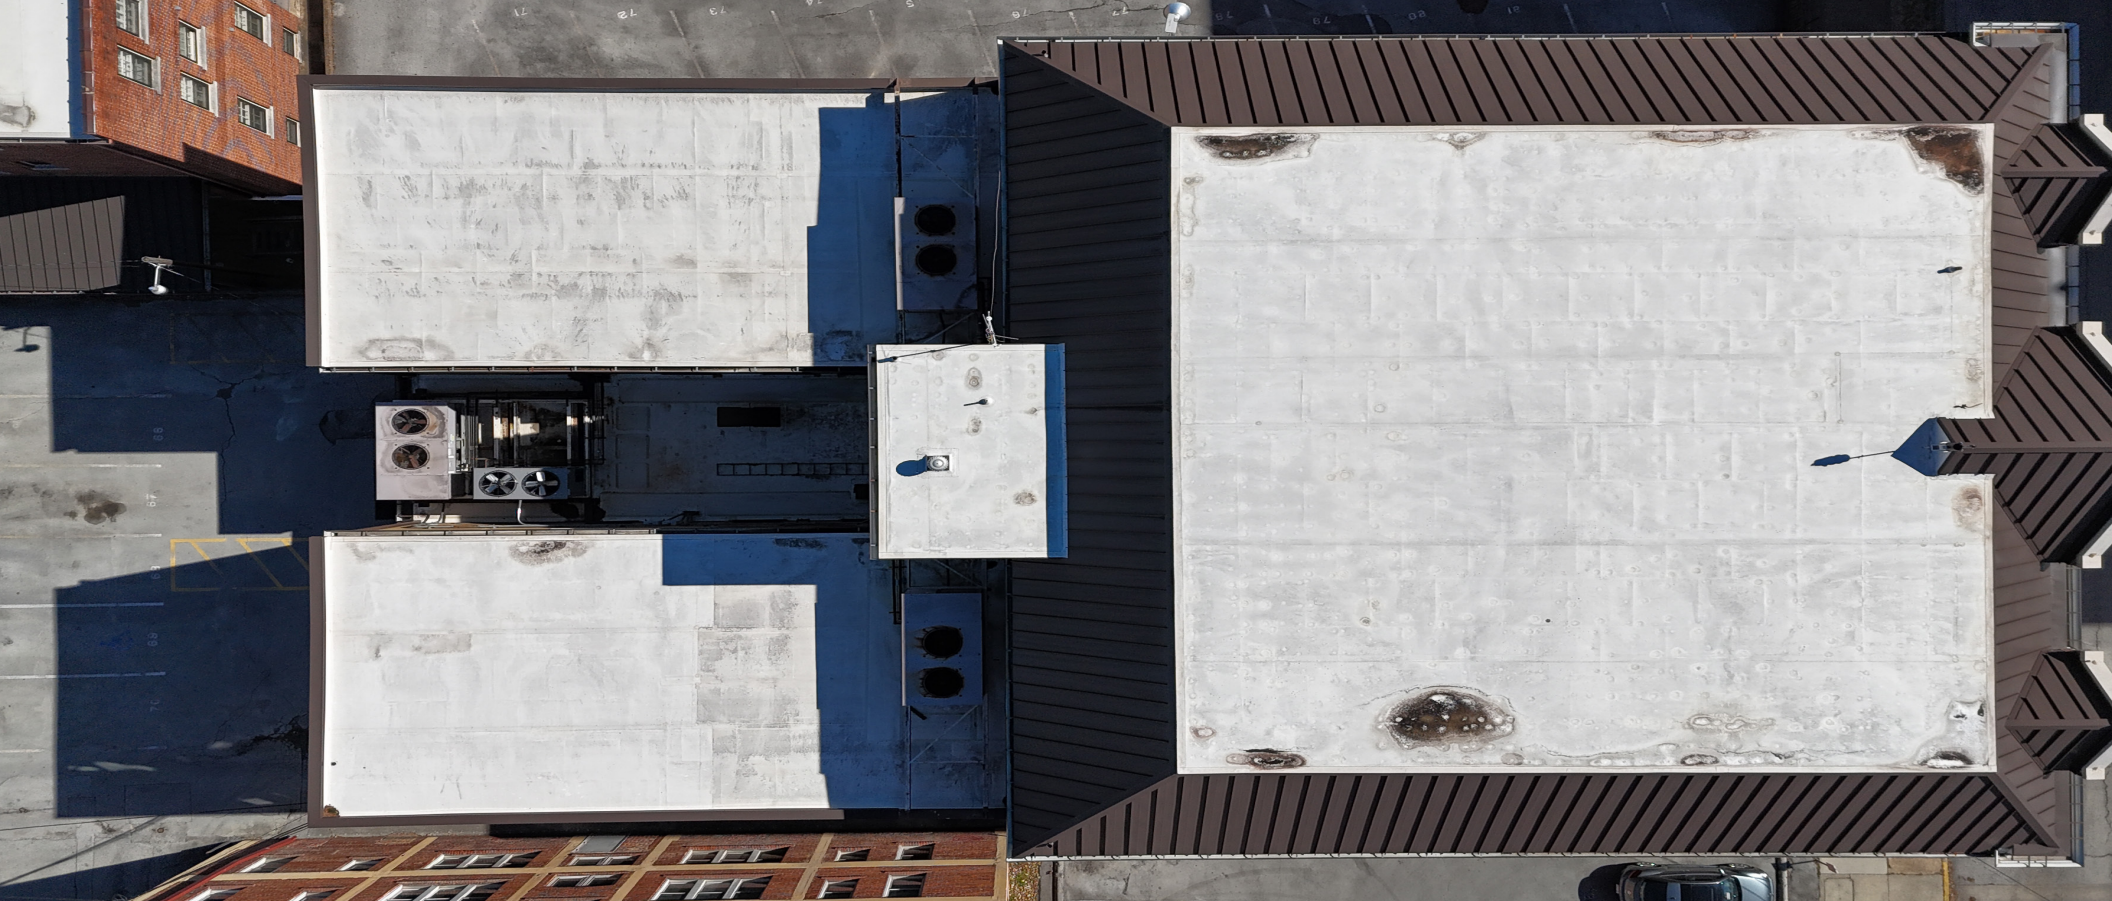
ROOFING

According to information provided by the County, the existing roof was installed in 2013 by TBM Roofing. In general, the existing roofing is in good condition. There is evidence of ponding water on the large flat portion of the 4th floor, but the roofing does not appear to be damaged. The standing seam metal roofing and gutters appear to be in good condition. There is a possibility that the flashing at the front parapet may be compromised and causing water to leak into the building on the 4th floor.

Membrane: Clean and repair as required.

Standing Seam Metal: Investigate the condition of the existing flashings at the front parapet and repair or replace as required.

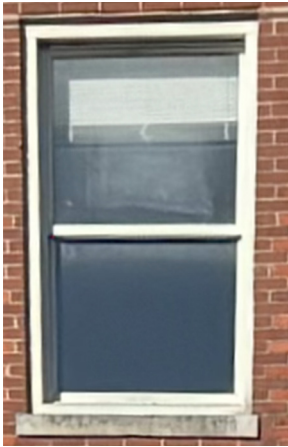
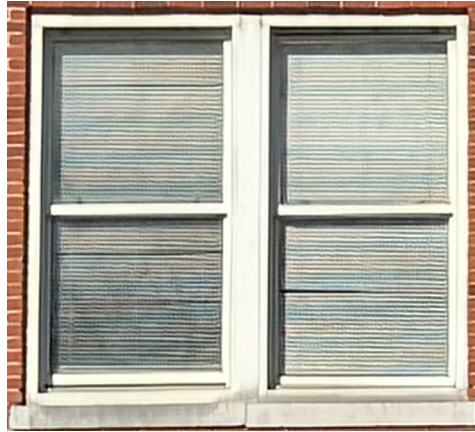
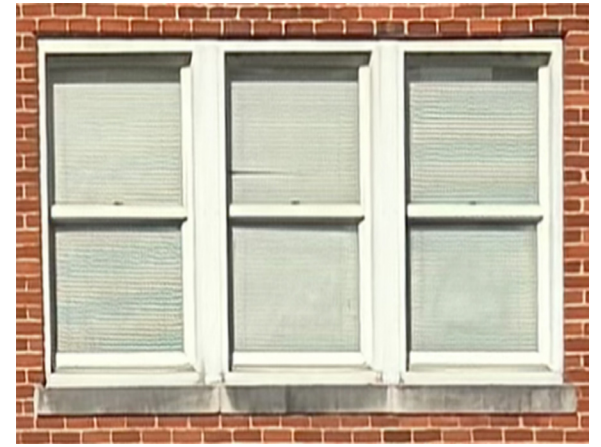
WINDOWS

The existing aluminum replacement windows, likely installed after the building's 1980 listing on the National Register of Historic Places, detract from its historic integrity. Furthermore, the condition of the window heads, jambs, and sills suggests potential for future water intrusion.

Windows: Install new historically appropriate windows and repair heads, jambs, and sills as required by cleaning and waterproofing the existing conditions.

If the windows are not replaced, we recommend cleaning and repairing the heads, jambs, and sills as much as possible.

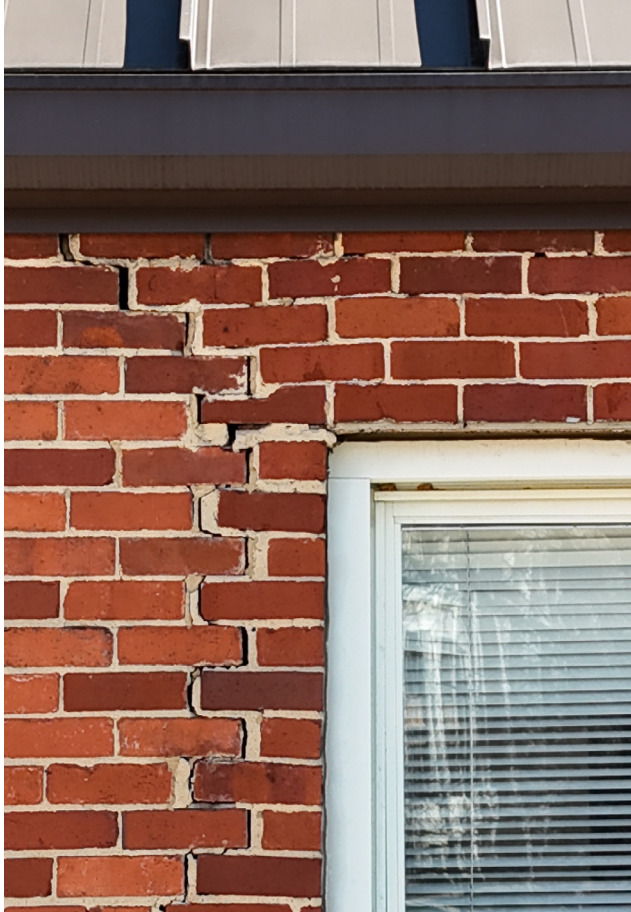
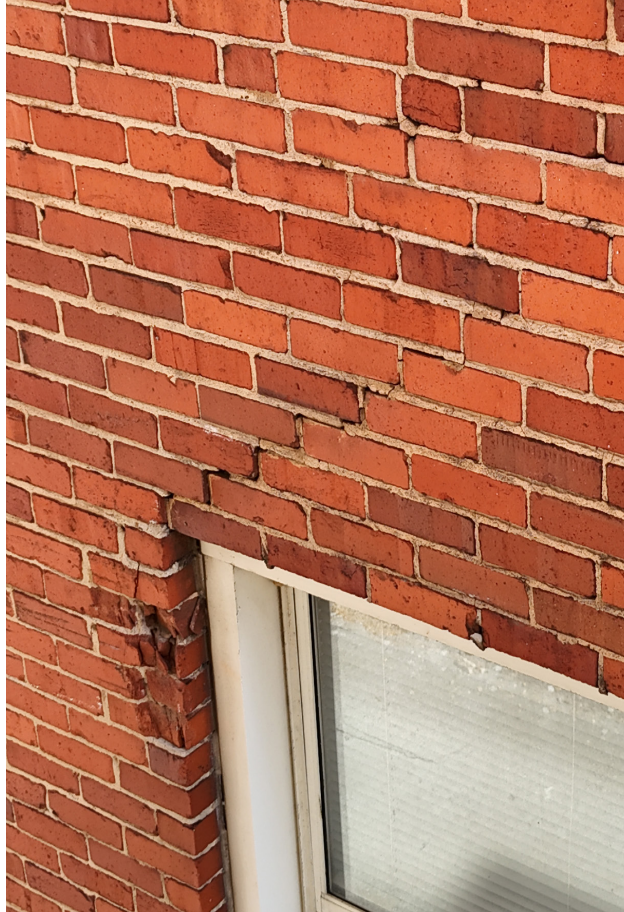
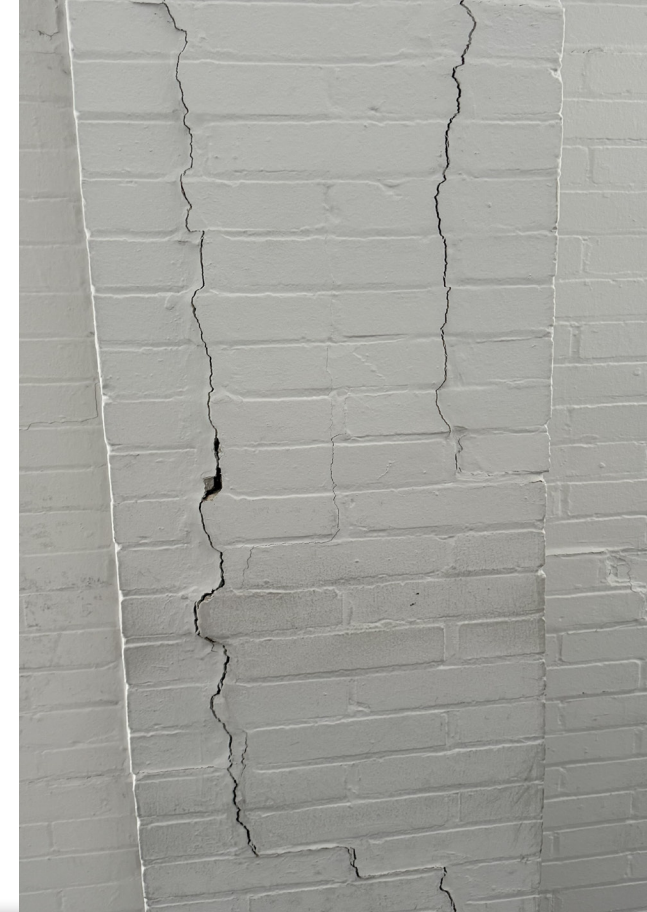
MASONRY

In general, the masonry is in good condition. The sandstone on the front façade (southern) appears to be in very good condition. Based on the visual investigation, the original mortar on the front façade has been pointed over, but even in areas where the “new” mortar has been removed, the original mortar appears to be in good condition as well. Similarly, the brick on the remaining facades appears to be in good condition. There is evidence of previous brick and mortar patching and pointing work scattered over all facades. There are a few areas where the brick and mortar have separated from each other as shown in the photographs above. In addition to the areas on the exterior, a brick pilaster on the 4th floor is also cracked and separating.

Exterior: Repair areas of cracking as required with brick and mortar compatible with the existing conditions and the historic nature of the building. Grind and point mortar joints as required. Wash and seal all rockface stone, limestone sills, base, bands, accents, and brick.

Interior: Repair interior pilaster. (Refer to the attached masonry proposal for more information on proposed method of repair.)

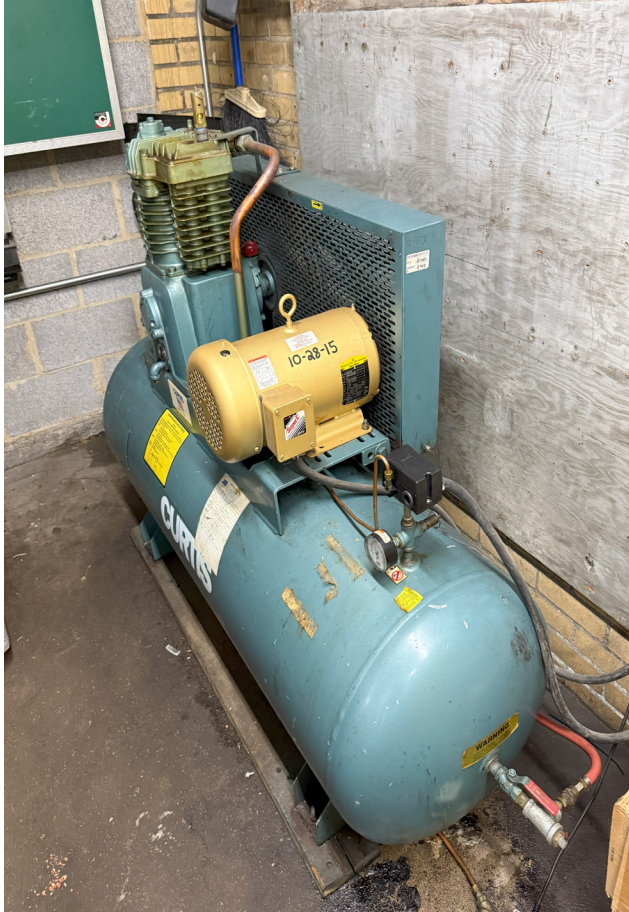
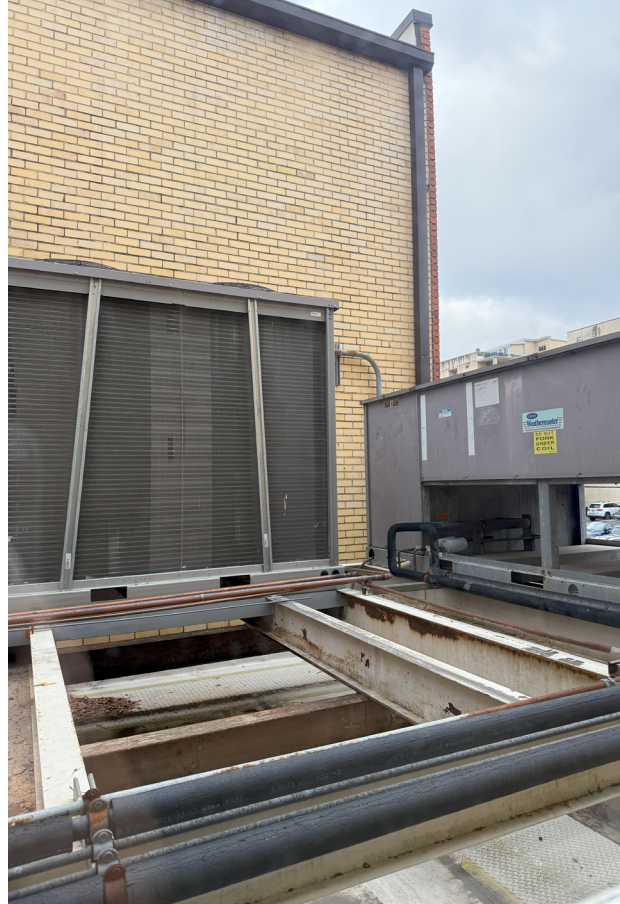
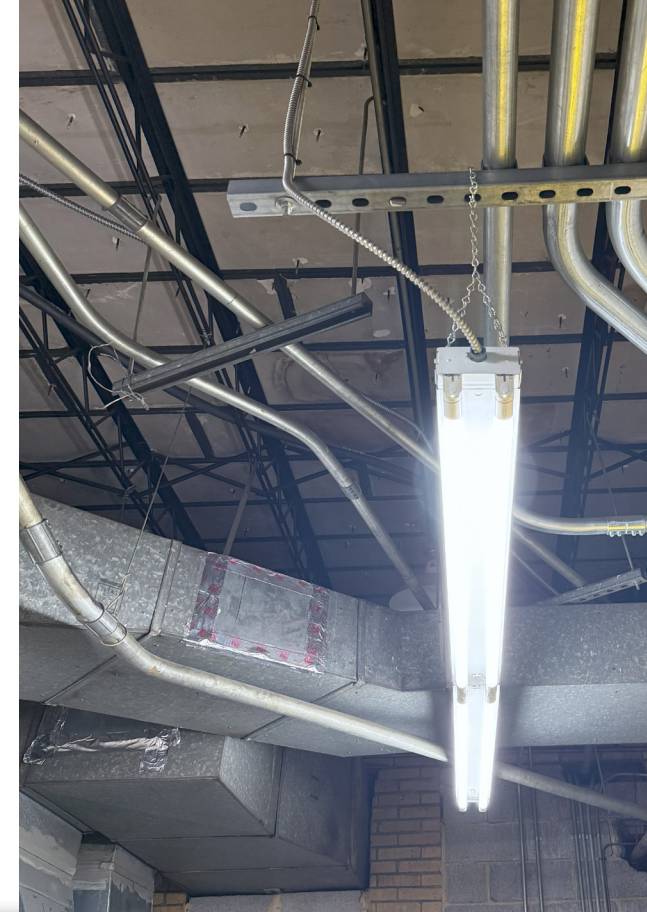
MECHANICAL

The existing mechanical systems include five large direct expansion (DX) split systems for cooling, with some units equipped with 2-stage fans but most being constant volume. The air handling units (AHUs) and condensing units were replaced in the early 2000s, with a few recent replacements. Heating and zone temperature control are managed by duct-mounted electric reheat coils and motorized control dampers. The control system uses pneumatic thermostats and damper actuators, with a Building Automation System (BAS) installed for the central AHUs. The ductwork is mostly rectangular, galvanized, and internally lined, with some reports of 'black soot' at supply diffusers indicating poor air quality. Ventilation air is limited, with only one AHU having a fresh air connection, and the building relies on operable windows for natural ventilation. The HVAC systems do not meet the current energy code, and there are issues with control zoning, corridor return air paths, and energy inefficiency.

Replace the mechanical systems including all lined ductwork with a Water Source Heat Pump (WSHP) system, which is preferred for its long-term energy and maintenance benefits. This system would involve installing new central plant equipment, including a boiler, closed circuit fluid cooler, and hydronic accessories, with a new gas service recommended. The WSHP units would be distributed throughout the building, with new ductwork and condensate piping. The design would also incorporate a Dedicated Outside Air System (DOAS) to provide fresh ventilation air.

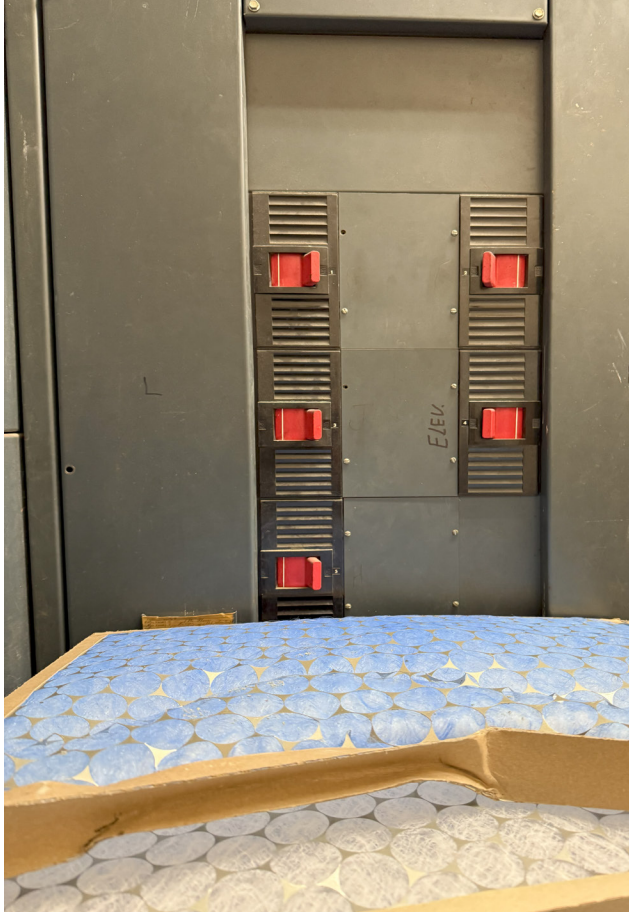
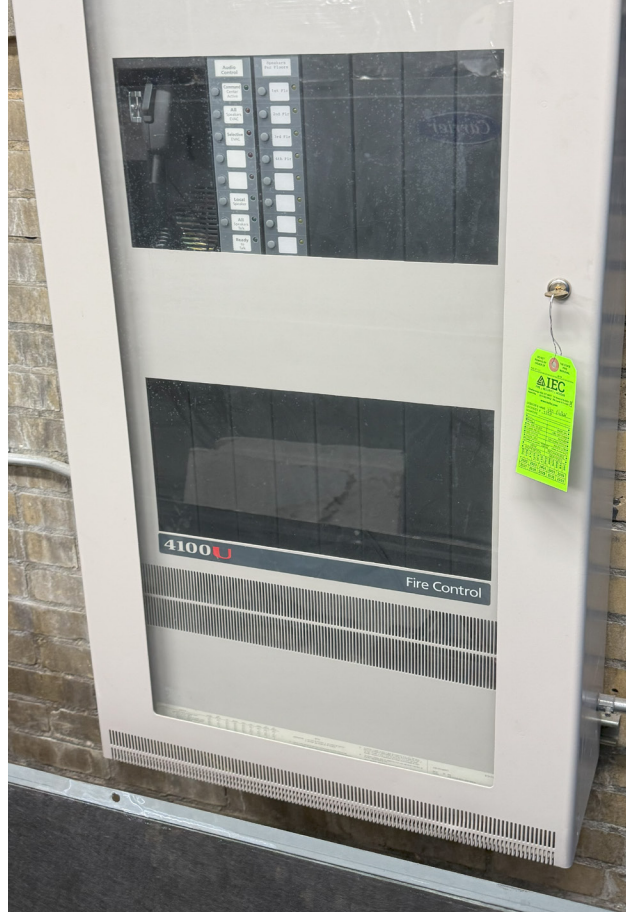
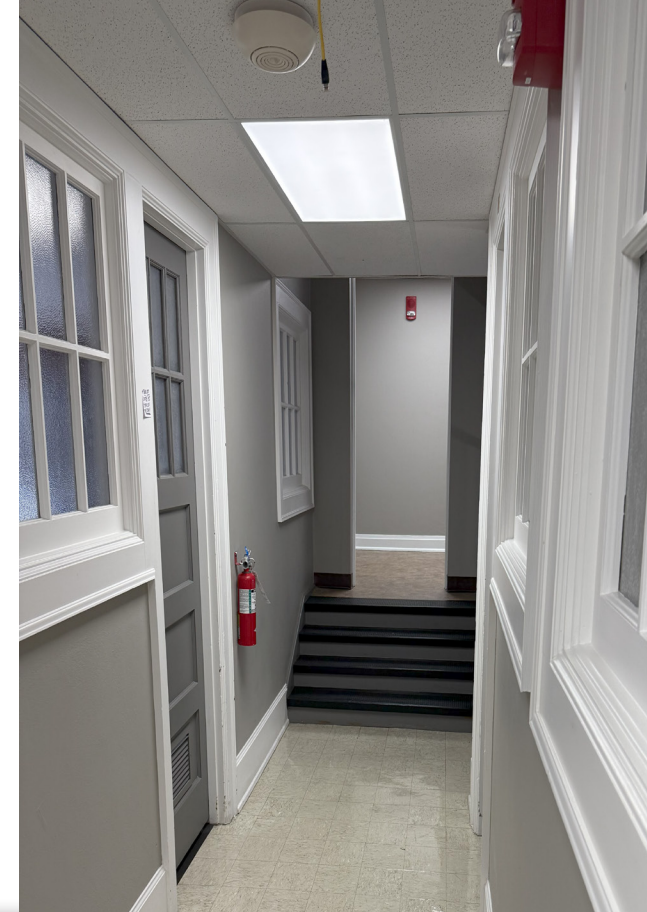
ELECTRICAL

The existing electrical system includes a 120/208V, 3-phase, 4-wire service from a pad-mounted transformer, with a 2000A GE switchboard that has a bolted pressure switch. This switchboard, along with most panelboards, is from the same installation period and has reached the typical lifespan of electrical equipment. The building's power distribution system includes GE type NAB/NHB and DB/NLTQ, NLAB panelboards, which are still functional but aged. The normal electrical distribution may need additional receptacles if the space layout changes, and the emergency lighting system, which uses "bug-eye" wall packs, has some fixtures that failed to operate during testing. Most interior lighting has been updated to LED flat panels, and the existing lighting controls are primarily wall-mounted toggle switches. The fire alarm system is relatively new, featuring a fully addressable Simplex 4100U fire alarm control panel.

Perform preventative maintenance on the bolted pressure switch or replace it with a modern circuit breaker, and re-torque all connections to prevent arc faults. The wall in front of the switchboard should be modified to ensure a minimum of 36 inches of clearance. For the HVAC renovation, new circuits, breakers, conductors, conduit, and supports will be required for the WSHP and DOAS units. It is also recommended to replace the emergency lighting fixtures instead of just the battery packs due to their age. Existing light fixtures will need temporary support during ceiling removal for ductwork replacement, and any exterior lighting should be replaced with LED fixtures as part of general maintenance. The fire alarm system can be modified or expanded as needed for the HVAC renovation and any layout modifications.

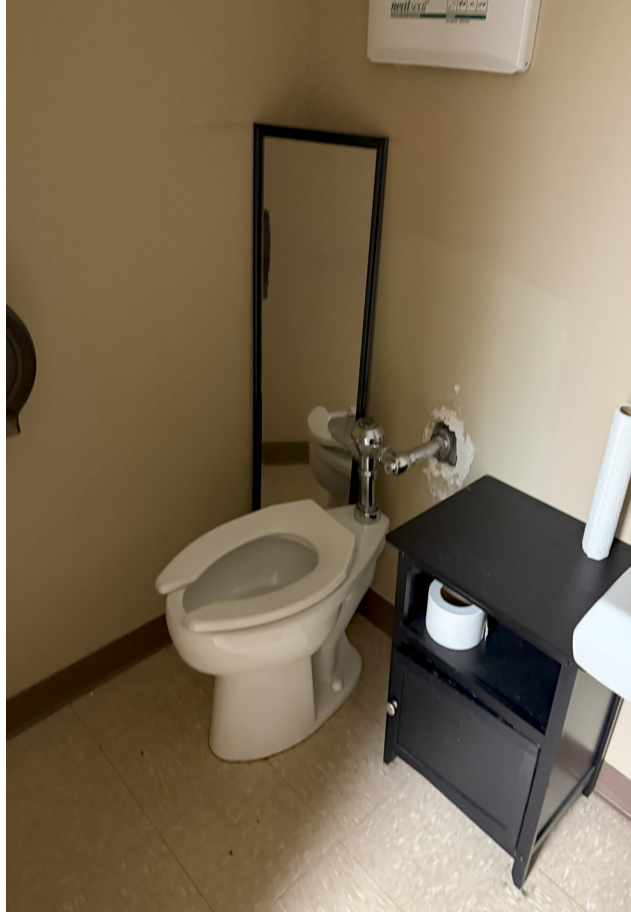
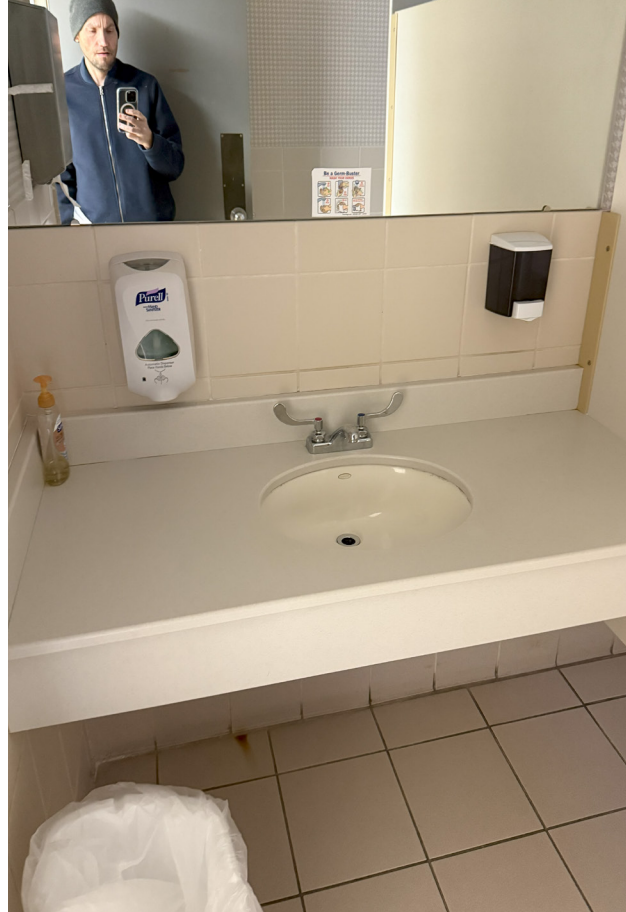
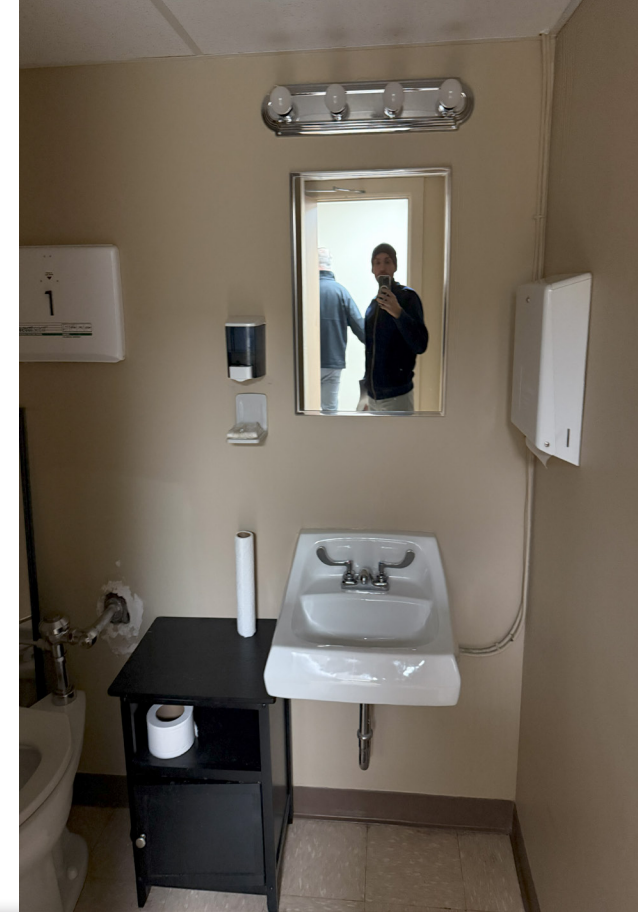
PLUMBING

The existing plumbing system includes domestic water service from Oak Street, with an 80-gallon electric tank water heater located in the first-floor mechanical room. The domestic water piping is primarily copper, with some newer sections made of PEX, and the main service line is galvanized steel. The sanitary piping is mostly cast iron with some newer CPVC sections, and it appears to be in fair condition despite some signs of previous leaks and rust. Public restroom fixtures, including lavatories, toilets, and urinals, have been replaced within the last 10 years and are in good working condition, although the lavatory flow rates exceed the current code maximum.

Replace as much exposed domestic and sanitary piping as possible during any major renovation, as this will be the most cost-effective and least intrusive time to do so. Replace the existing public lavatories with faucets that comply with the maximum flow rate of 0.5 GPM. Refer to the Accessibility section above for modifications to existing bathrooms for ADA compliance.
