**Martin Luther King, Jr. Human Services Center HVAC Analysis  
Report For Hamilton County Government**

**February 13, 2018**

**Written by Campbell & Associates, Inc.**

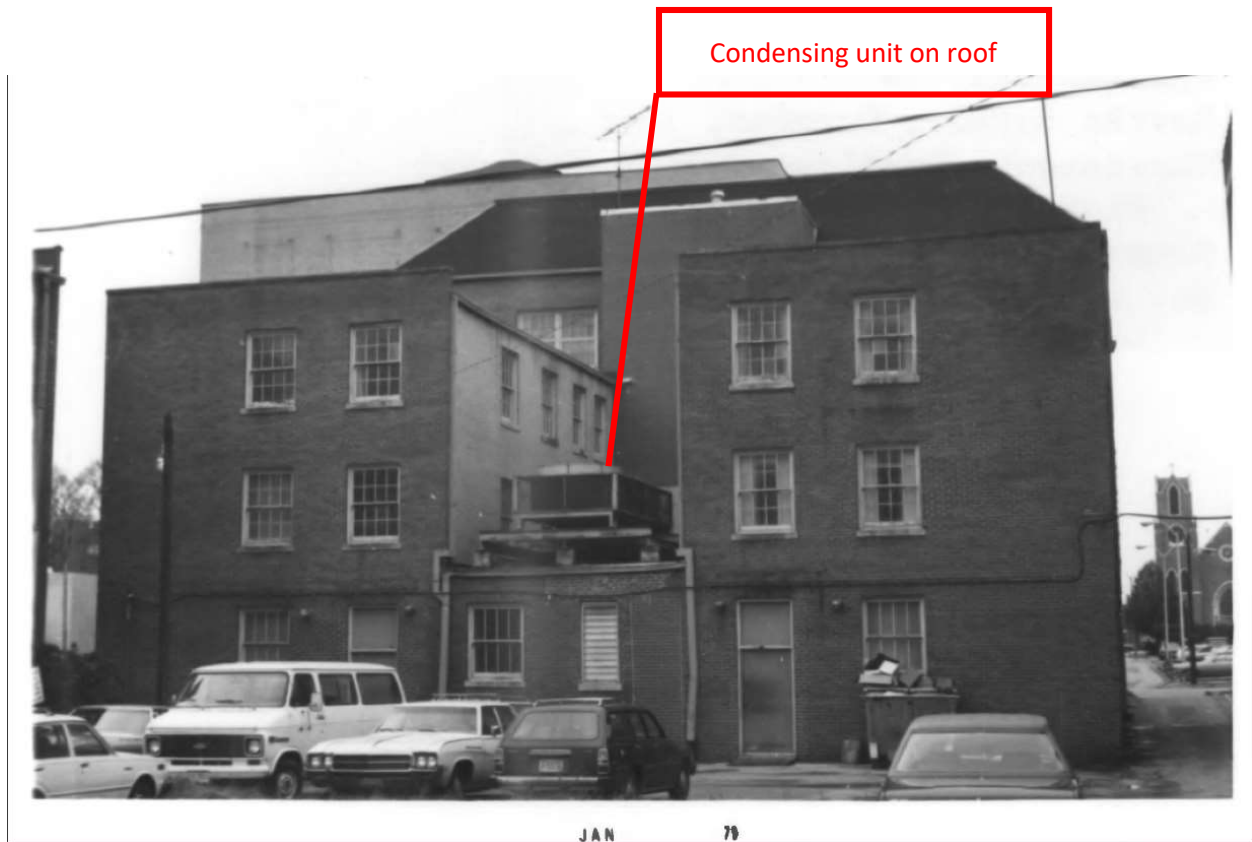
**1979 Photo of the Rear Side of Building**

Although the MLK building was originally built in 1928, there are no as-built documentation that states when the original HVAC systems were first installed. DX type cooling systems were not prolific during the 1920's when the building was first constructed and it is possible that the building was originally built with a heating only system. The digital archive for the National Register of Historic Places<sup>1</sup> does show the presence of a HVAC condensing unit installed on the first-floor roof (see "1979 Photo of the Rear Side of Building") so a pre-1979 install date for an HVAC system utilizing a large condensing unit can be assumed. Available documentation shows that new cooling only HVAC equipment was installed in existing ductwork near 2001. Field acquired data confirms this date as well. This indicates that the ductwork, ductwork lining, electric reheat, control dampers, and controls within the building was installed at least prior to 1979 which is a minimum of 39 years.

- A cooling tower (please see "*Cooling Tower Example (With Interior Cutaway)*") could be located on the roof of the first floor (please see "*1979 Photo of the Rear Side of Building*") where there are currently two existing condensing units. Cooling towers have an estimated service life of 20 years per SMACNA.

- The outdoor mounted heat pump could be located on the roof of the first floor (*please see "1979 Photo of the Rear Side of Building"*) where there are currently two existing condensing units.

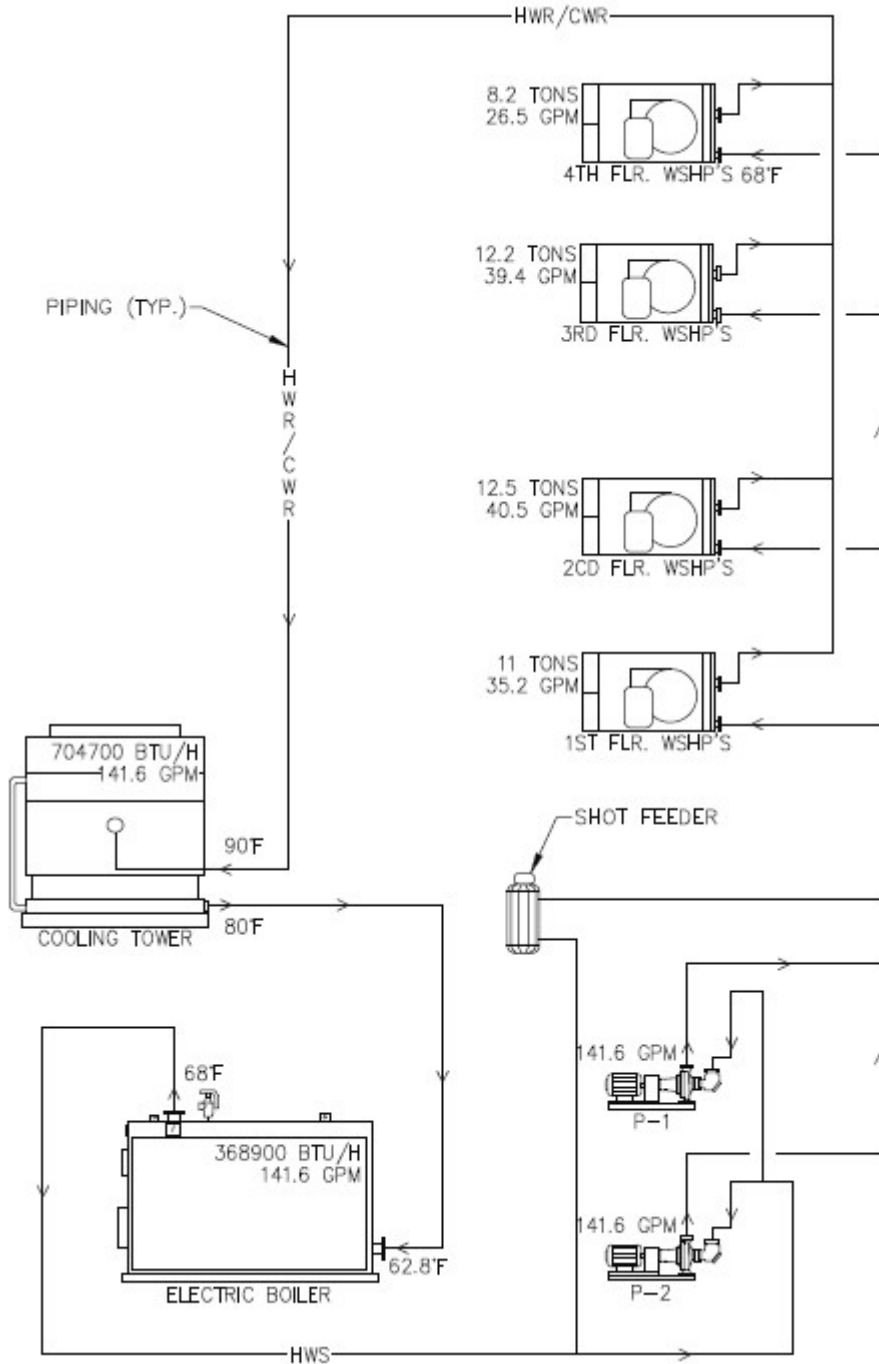
**WSHP System Schematic**

In order to best comply with the zoning requirements, to meet current codes, while modifying the building structure as little as possible, a water source heat pump (WSHP) system may be a viable solution. WSHP's are heat pumps that reject or take heat from water verses outside air. Water is circulated through piping from WSHP's to a boiler and/or cooling tower where heat is either added or taken. Please see the "*WSHP System Schematic*" for further components of the respective system.

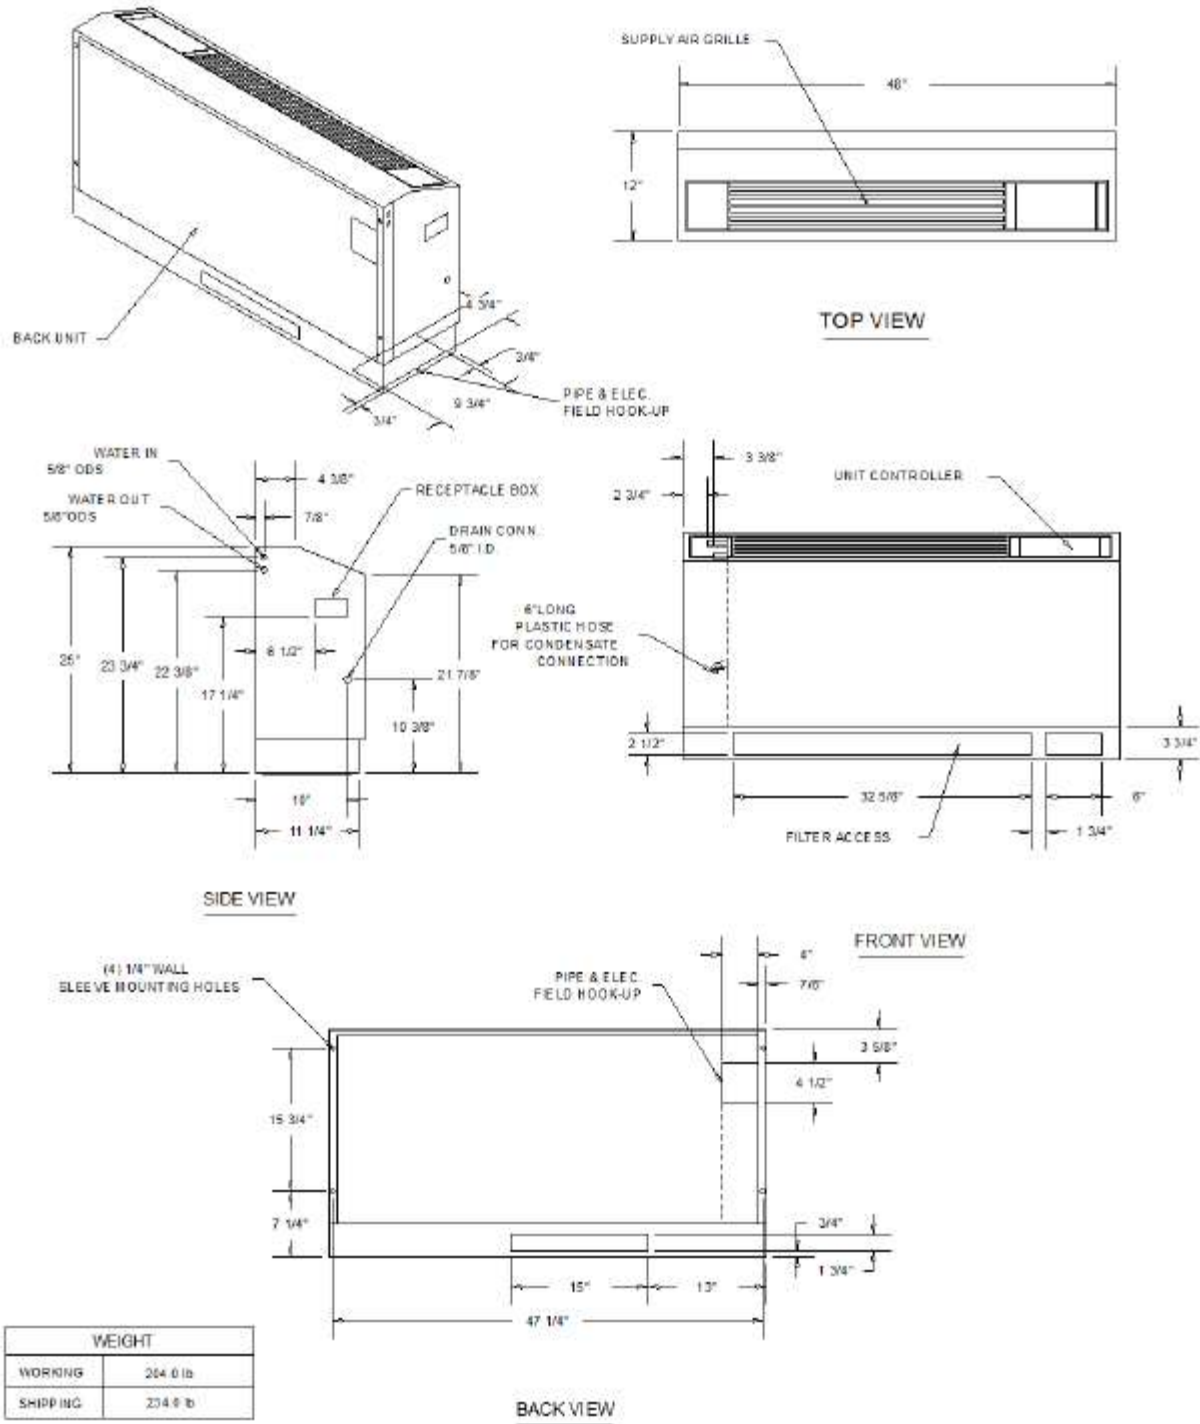
**WSHP Floor Mounted Console Unit Example (1.25 Ton)**

- Improved zoning, minimizing the impact of minimal above ceiling heights, as well as the elimination of corridor returns can be accomplished by utilizing Floor Mounted Console Units (see "*Floor Mounted Console Unit Example*") or Vertical Stack Units (See "*WSHP Vertical Stack Unit Example (1 Ton)*") in respective spaces in order to provide individual occupants with their own temperature control. All of the return air would be retained within the individual space. Vertical Stack units would require the units to be aligned or stacked per floor since each share a common riser. Consoles or Stacked units would require minimal ductwork if any.

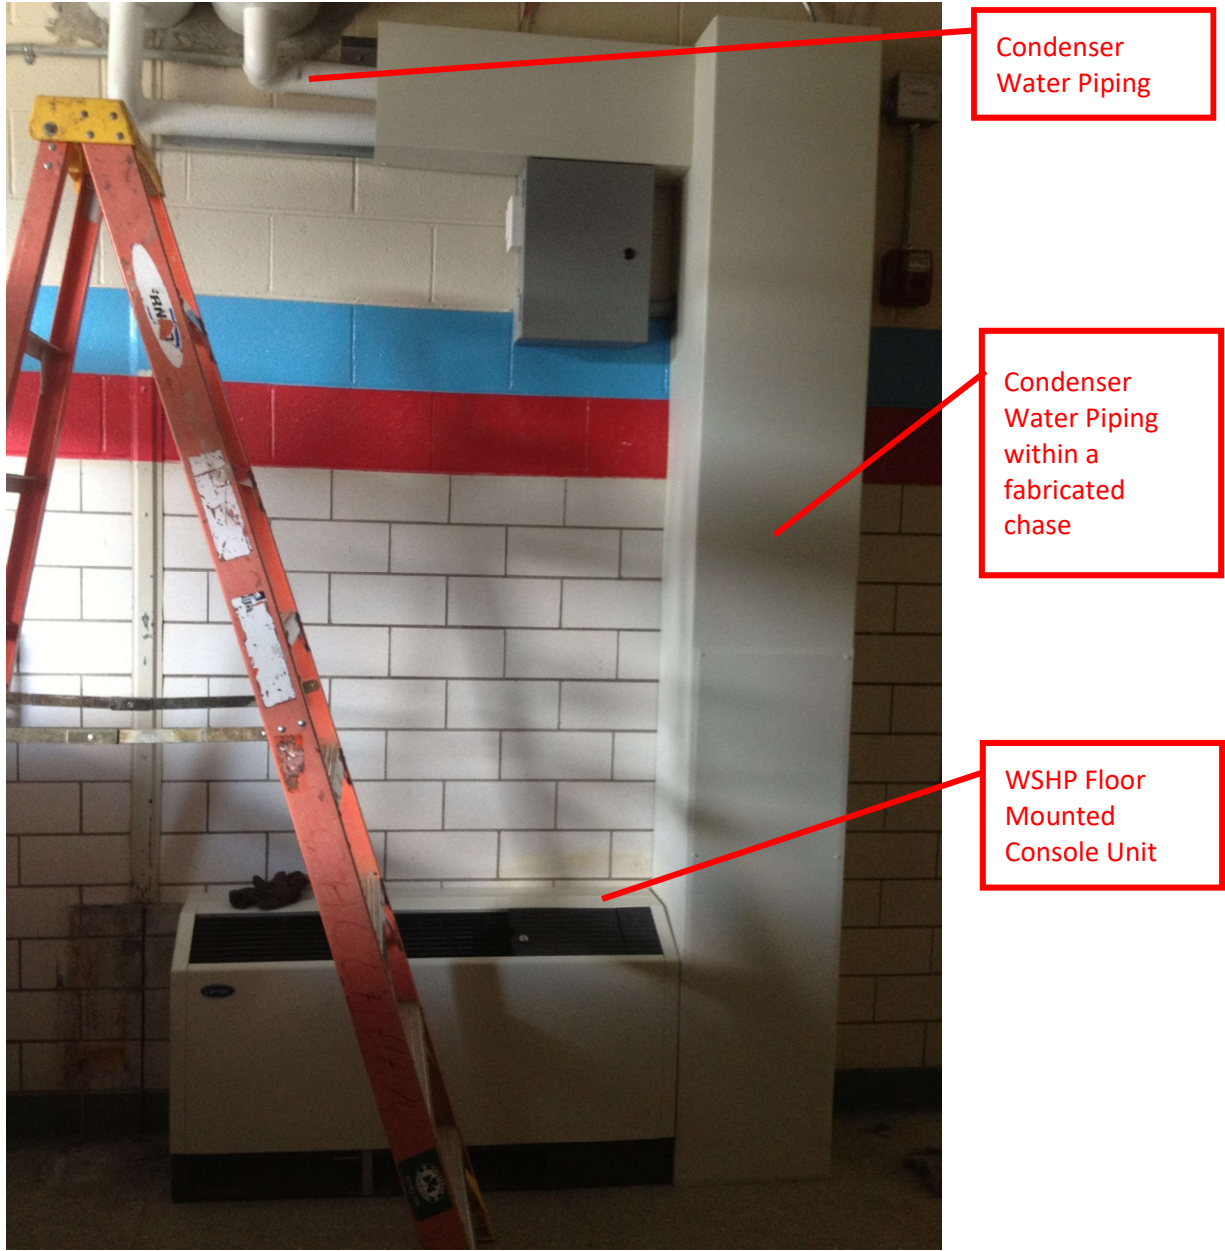
WSHP Floor Mounted Console Unit Installation Example

- Should console type units be utilized, fabricated chases may be required (See "*WSHP Floor Mounted Console Unit Installation Example*") in order to cover and protect piping from the ceiling to the floor that would otherwise be routed exposed to view due to the presence of existing walls. The appearance of fabricated chases may seem unsightly to some, even though the chases can be painted to match the existing wall.

- As with WSHP Console units, Floor Mounted Terminal type units may require fabricated chases (*See "WSHP Floor Mounted Console Unit Installation Example"*) in order to cover and protect piping from the ceiling to the floor that would otherwise be routed exposed to view due to the presence of existing walls. These chases would be smaller for VRF systems since refrigerant piping is smaller than water piping. The appearance of fabricated chases may seem unsightly to some even though the chases can be painted to match the wall they are in front of.

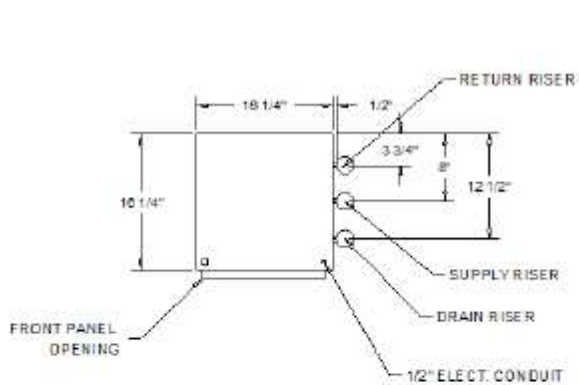
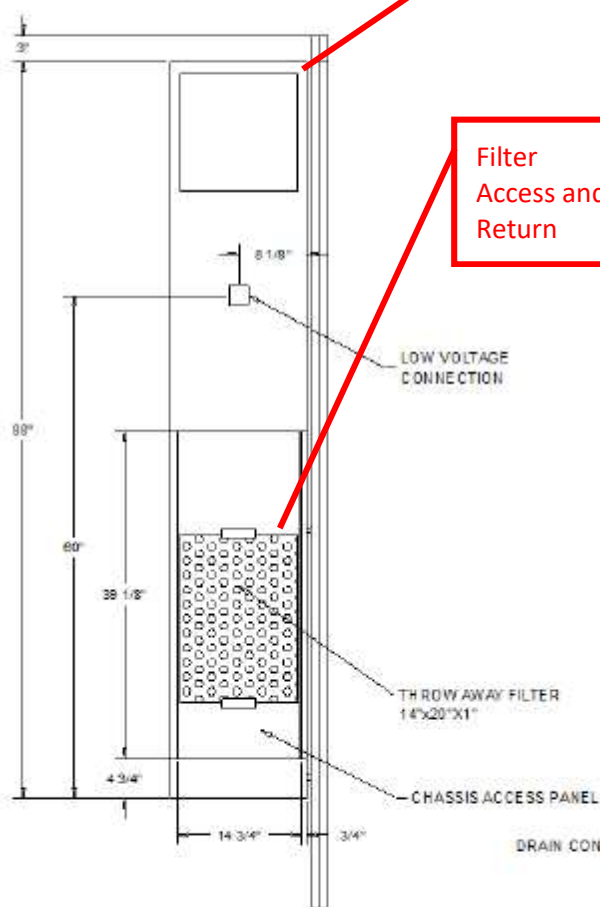
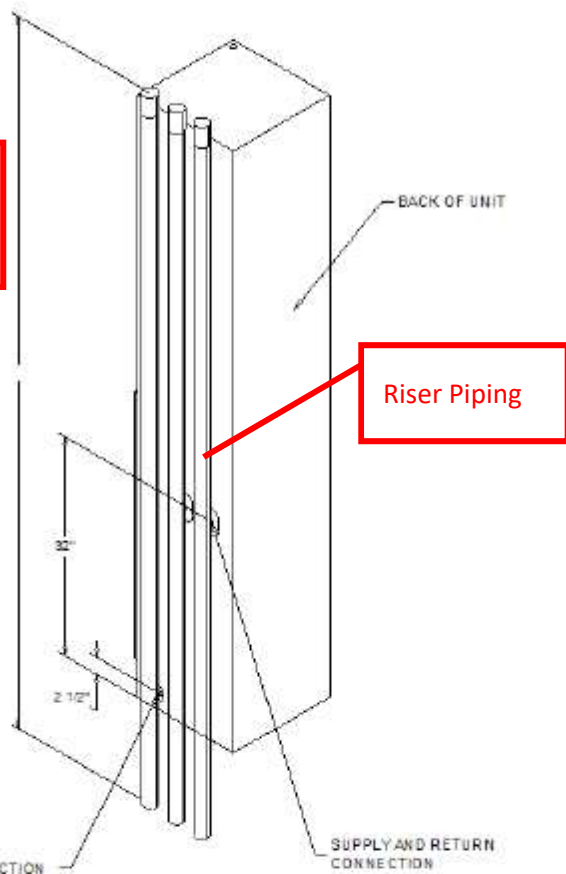
**WSHP Vertical Stack Unit Example (1 Ton)**

- NOTES:
1. DIMENSION FROM TOP OF UNIT TO SUPPLY OPENING ON ALL SIDES IS 1 1/2".
  2. DIMENSION FROM CENTER OF RISER TO CABINET IS DEPENDENT ON RISER DIAMETER PLUS 1/2" INSUL.
  3. IF TRANE RETURN AIR DOORS ARE NOT INSTALLED, A SOLUTION AT THE JOBSITE WILL BE REQUIRED TO SEAL GAPS BETWEEN CABINET AND FILTER DOOR.

WIDTH	HEIGHT
SUPPLY SIZE	14"	14"

Supply Air Connection

Filter Access and Return

Riser Piping

WEIGHT	
SHIPPING	135.0 lb
WORKING	115.0 lb

- A stacked unit would also need to be built into a chase within the respective room it is installed and would require a special door for access (See "*WSHP Vertical Stack Unit Return Air Door Example (1 Ton)*").

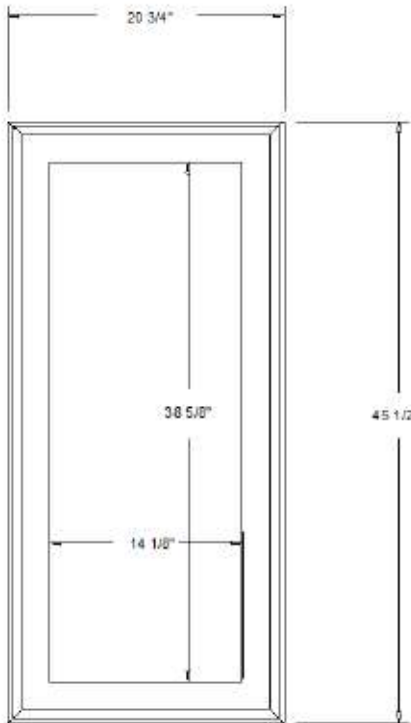
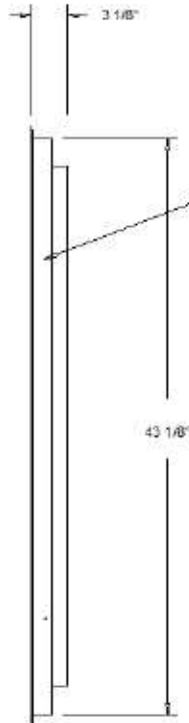
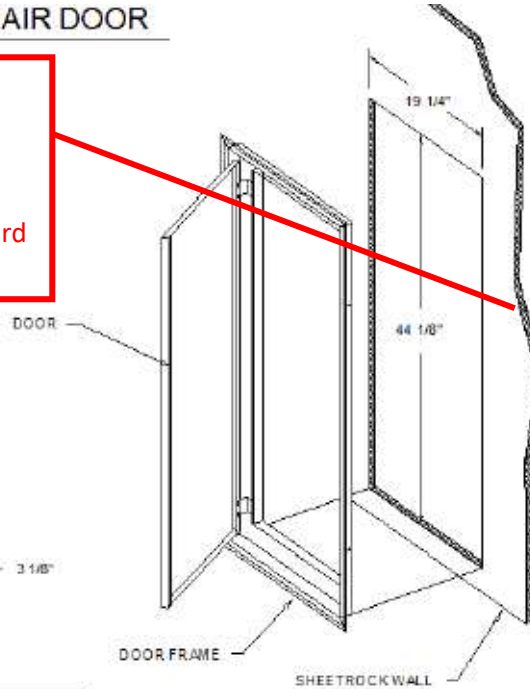
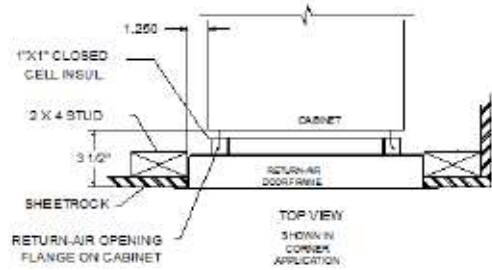
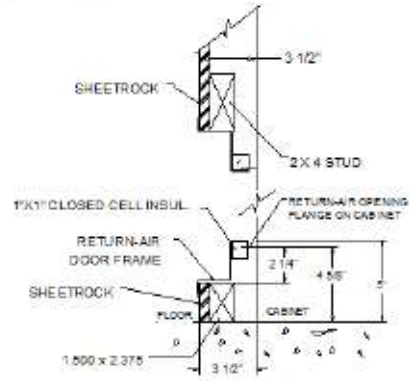
## WSHP Vertical Stack Unit Return Air Door Example (1 Ton)

Stacked Unit located behind gyp. Board chase

(4) HOLES TO SCREW DOOR FRAME TO 2 x 4

TOP VIEW SHOWN IN CORNER APPLICATION

RETURN AIR DOOR MOUNTING DETAIL

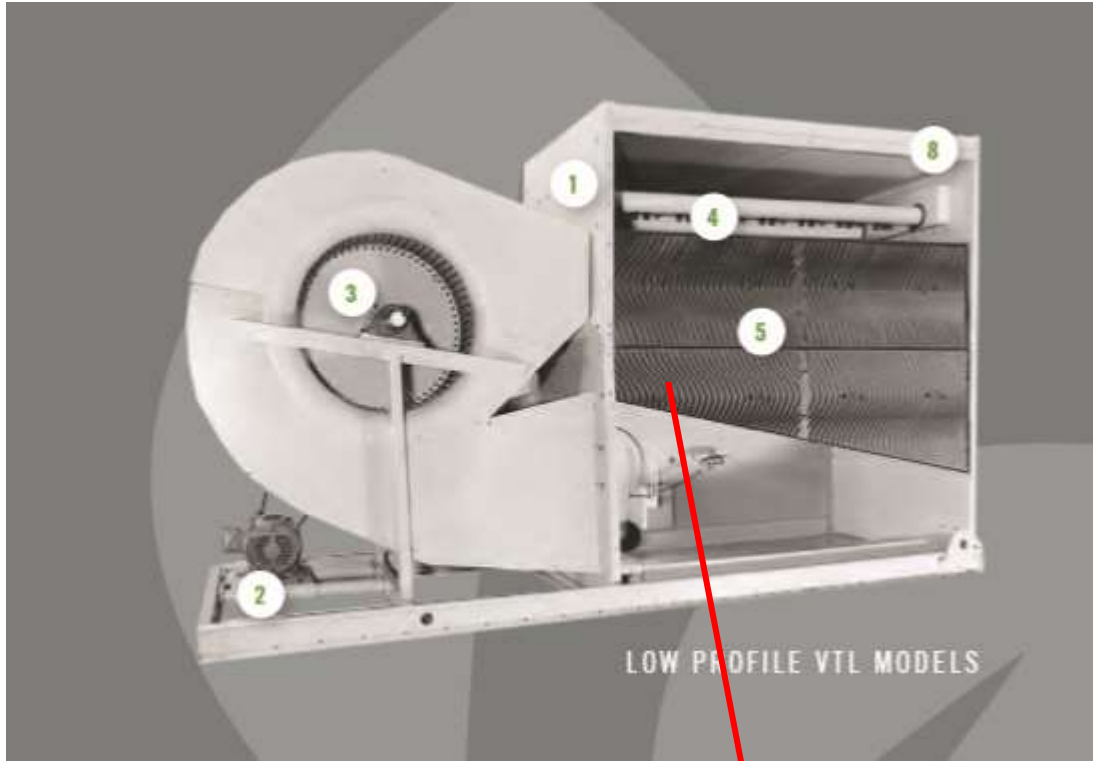
**Cooling Tower Example (With Interior Cutaway)**

In order to best match the footprint and weight requirements of the structure supporting the existing condensing units, an open cooling tower will require utilization due to its smaller footprint and lower weight than closed cooling towers.

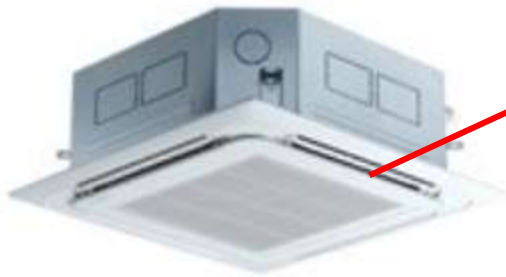
**Ceiling Mounted Terminal Unit Example**

The white section of the unit is mounted to the ceiling and seen from below. This unit acts as a supply and return.

- As with WSHP's, improved zoning as well as the elimination of corridor returns can be accomplished by the VRF system through the use of either Floor Mounted Terminal Units (*see "Floor Mounted Terminal Unit Example"*), Ceiling Mounted Terminal Units (*see "Ceiling Mounted Terminal Unit Example"*), or Ducted Terminal Units (*see "Ducted Terminal Unit Example"*) in respective spaces in order to provide individual occupants with their own temperature control. Even with the ducted terminal units, all of the return air would be retained within the individual space. VRF ducted terminal units are not very large (a 1 ton ducted terminal unit has a height of 10- $\frac{1}{4}$ " ) and are designed to be installed in areas with minimal ceiling space.

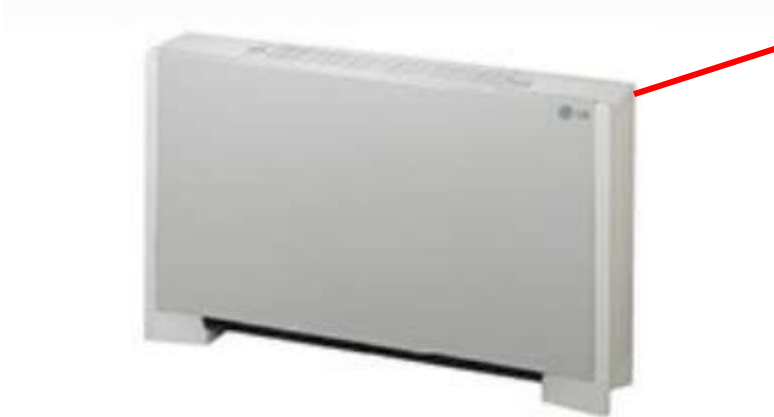
**Floor Mounted Terminal Unit Example**

This side of the unit is typically mounted against or in a wall

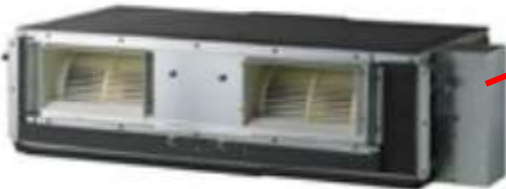
**Ducted Terminal Unit Example**

The unit is mounted entirely above the ceiling. Typ. 10-1/4" tall.

- Vertical Ducted Terminal Units are available to be utilized for larger areas but will require ductwork. These units have typical capacities of 5 tons or less so care must be taken in their application.

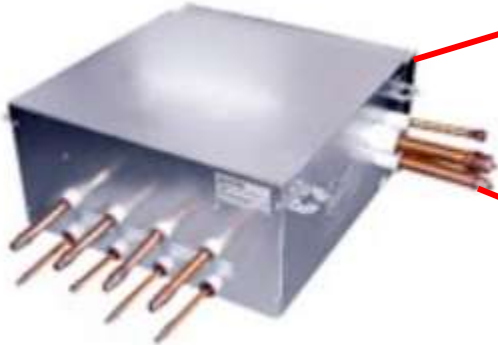
**Branch Unit Example**

The unit is mounted entirely above the ceiling.

Refrigerant piping connections (typ.)
